Limited Visual Dam Safety Inspections

Reservoir 545A

Oahu, Hawaii

Limited Visual Dam Safety Inspection Conducted on: 4 April 2006

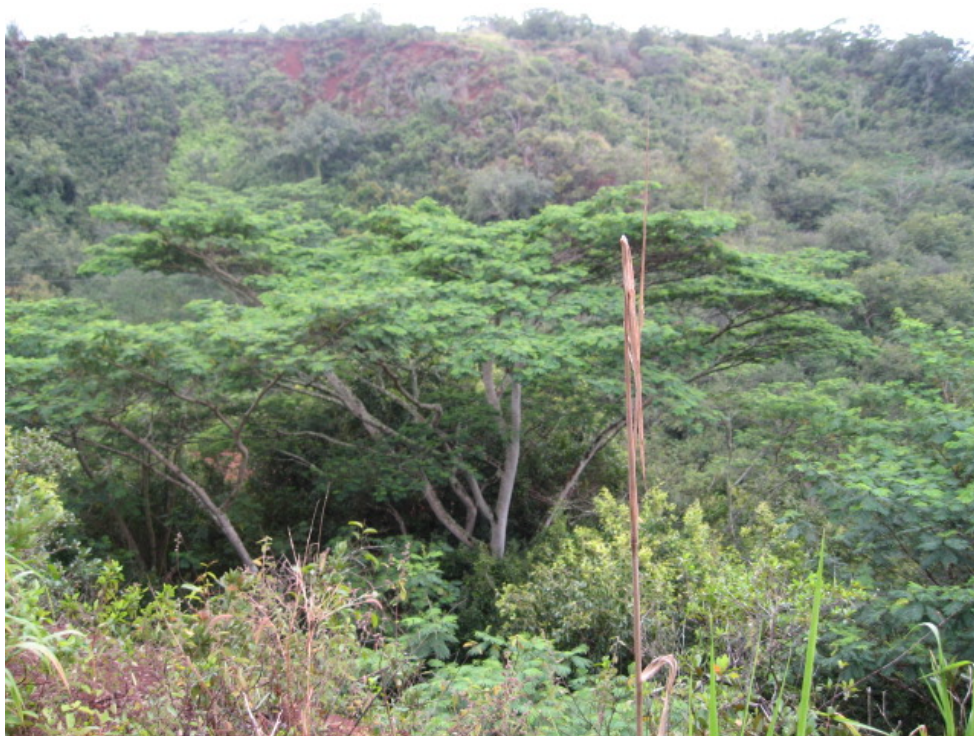
Vegetation was observed on the edges of the crest. These were primarily small woody vegetation and high grass.

- a. The dam crest was not inspected.
- b. The dam crest appeared to be in fair to poor condition and requires corrective action.
- c. Access along the crest was not possible. Description: Heavy vegetation

Photo 1 Dam crest, dense vegetation.

- e. Tree(s) were observed along the dam crest. Trees have been identified as the probably cause of piping failures, and can possibly cause severe damage to the embankment if they are uprooted during a high winds. Corrective action is required to remove the tree hazards from the dam. Acceptable remedies include removal of the tree and its root structure down to a 2" diameter and reconstructing the damaged embankment section. All repair work shall be accomplished as per the requirements of licensed geotechnical or structural engineer. Routinely monitor the damaged area for signs of settlement and seepage.

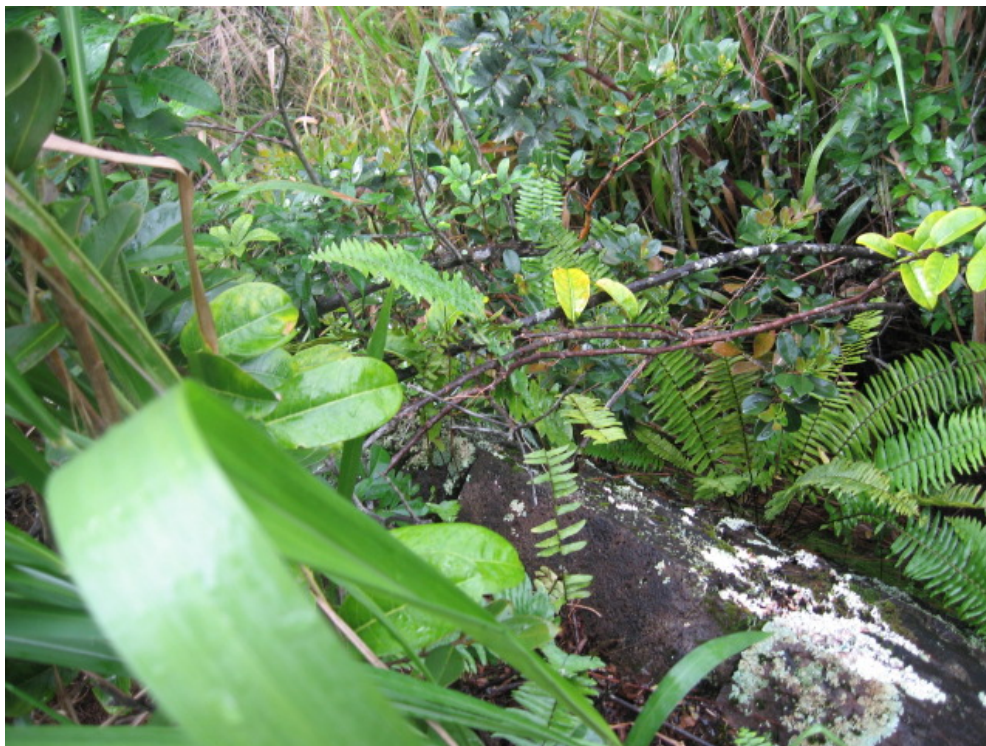
- a. The Spillway appeared to be in fair to poor condition and requires corrective action.
- b. Trees are unacceptable in the spillway channel and approach. Take corrective action to address the woody vegetation problem and repair the damaged area.
- c. Unclear if spillway is adequately sized. Spillway should pass the probable maximum flood. Verify spillway capacity and take corrective action as required.

Photo 2 Spillway, dense vegetation.

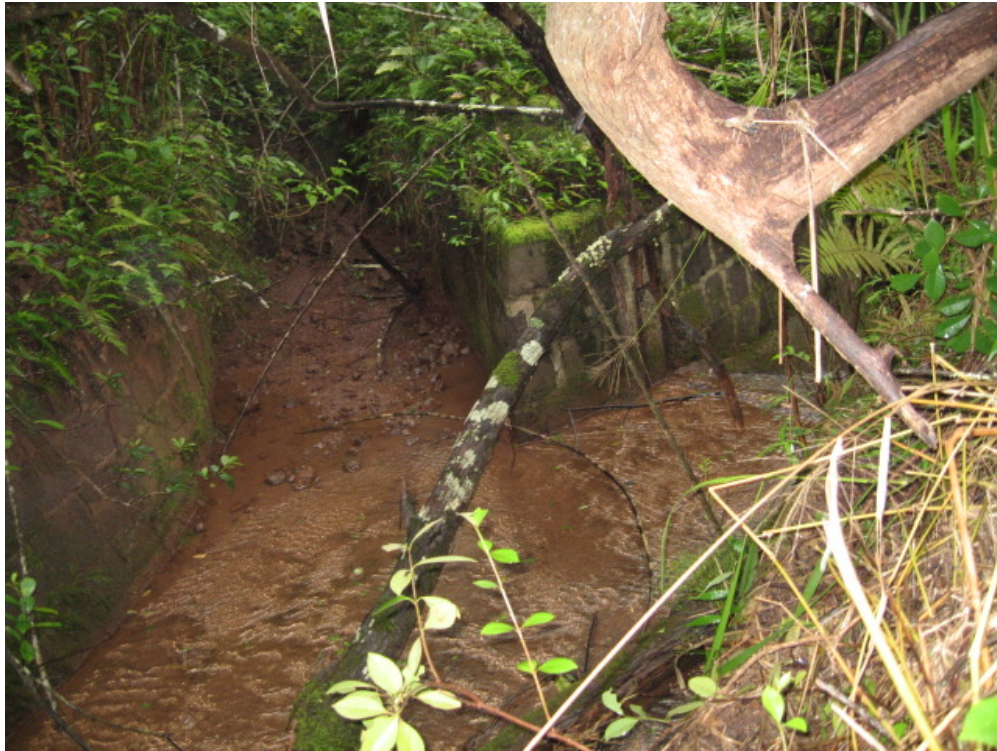
Photo 3 Outlet channel.

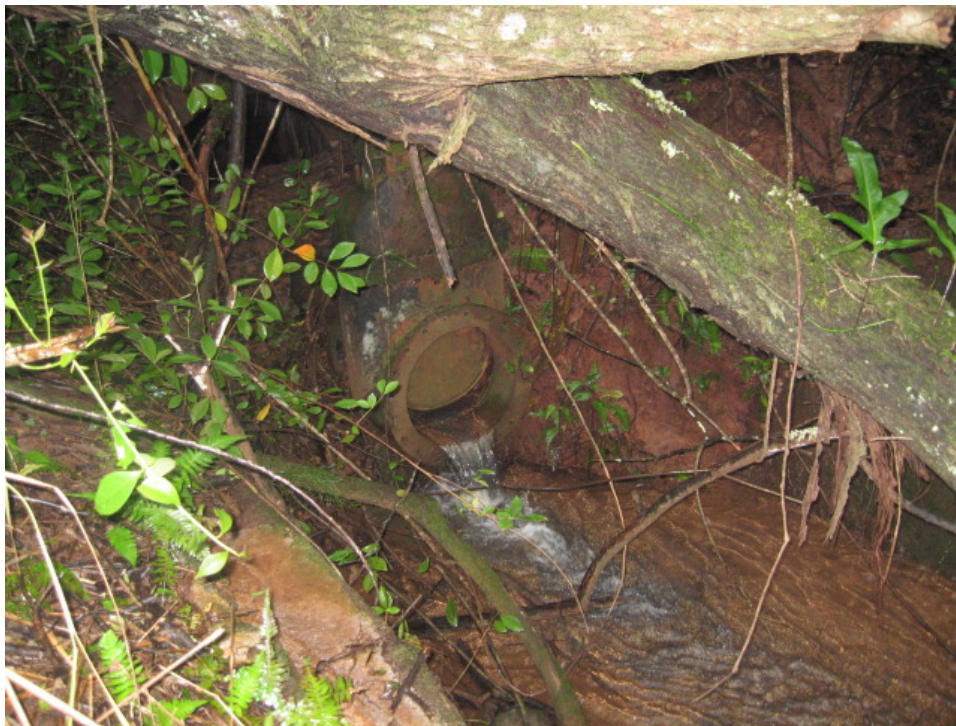
The outlet works appeared to be a 24" steel pipe, but the inlet was not found.

- a. The outlet works were not tested.
- b. The outlet works appeared to be in fair to poor condition and requires corrective action.
- c. The status of the intake is unknown.

Photo 4 Outlet pipe and valve.
